ONTARIO THRUWAY  
MONTEZUMA SWAMP  
SPOIL BANK SLIDE  
CLYDE RIVER RELOCATION

CATSKILL THRUWAY  
DELAWARE AVENUE SLIDE

EMBANKMENT FOUNDATION PROBLEMS IN SYRACUSE AREA

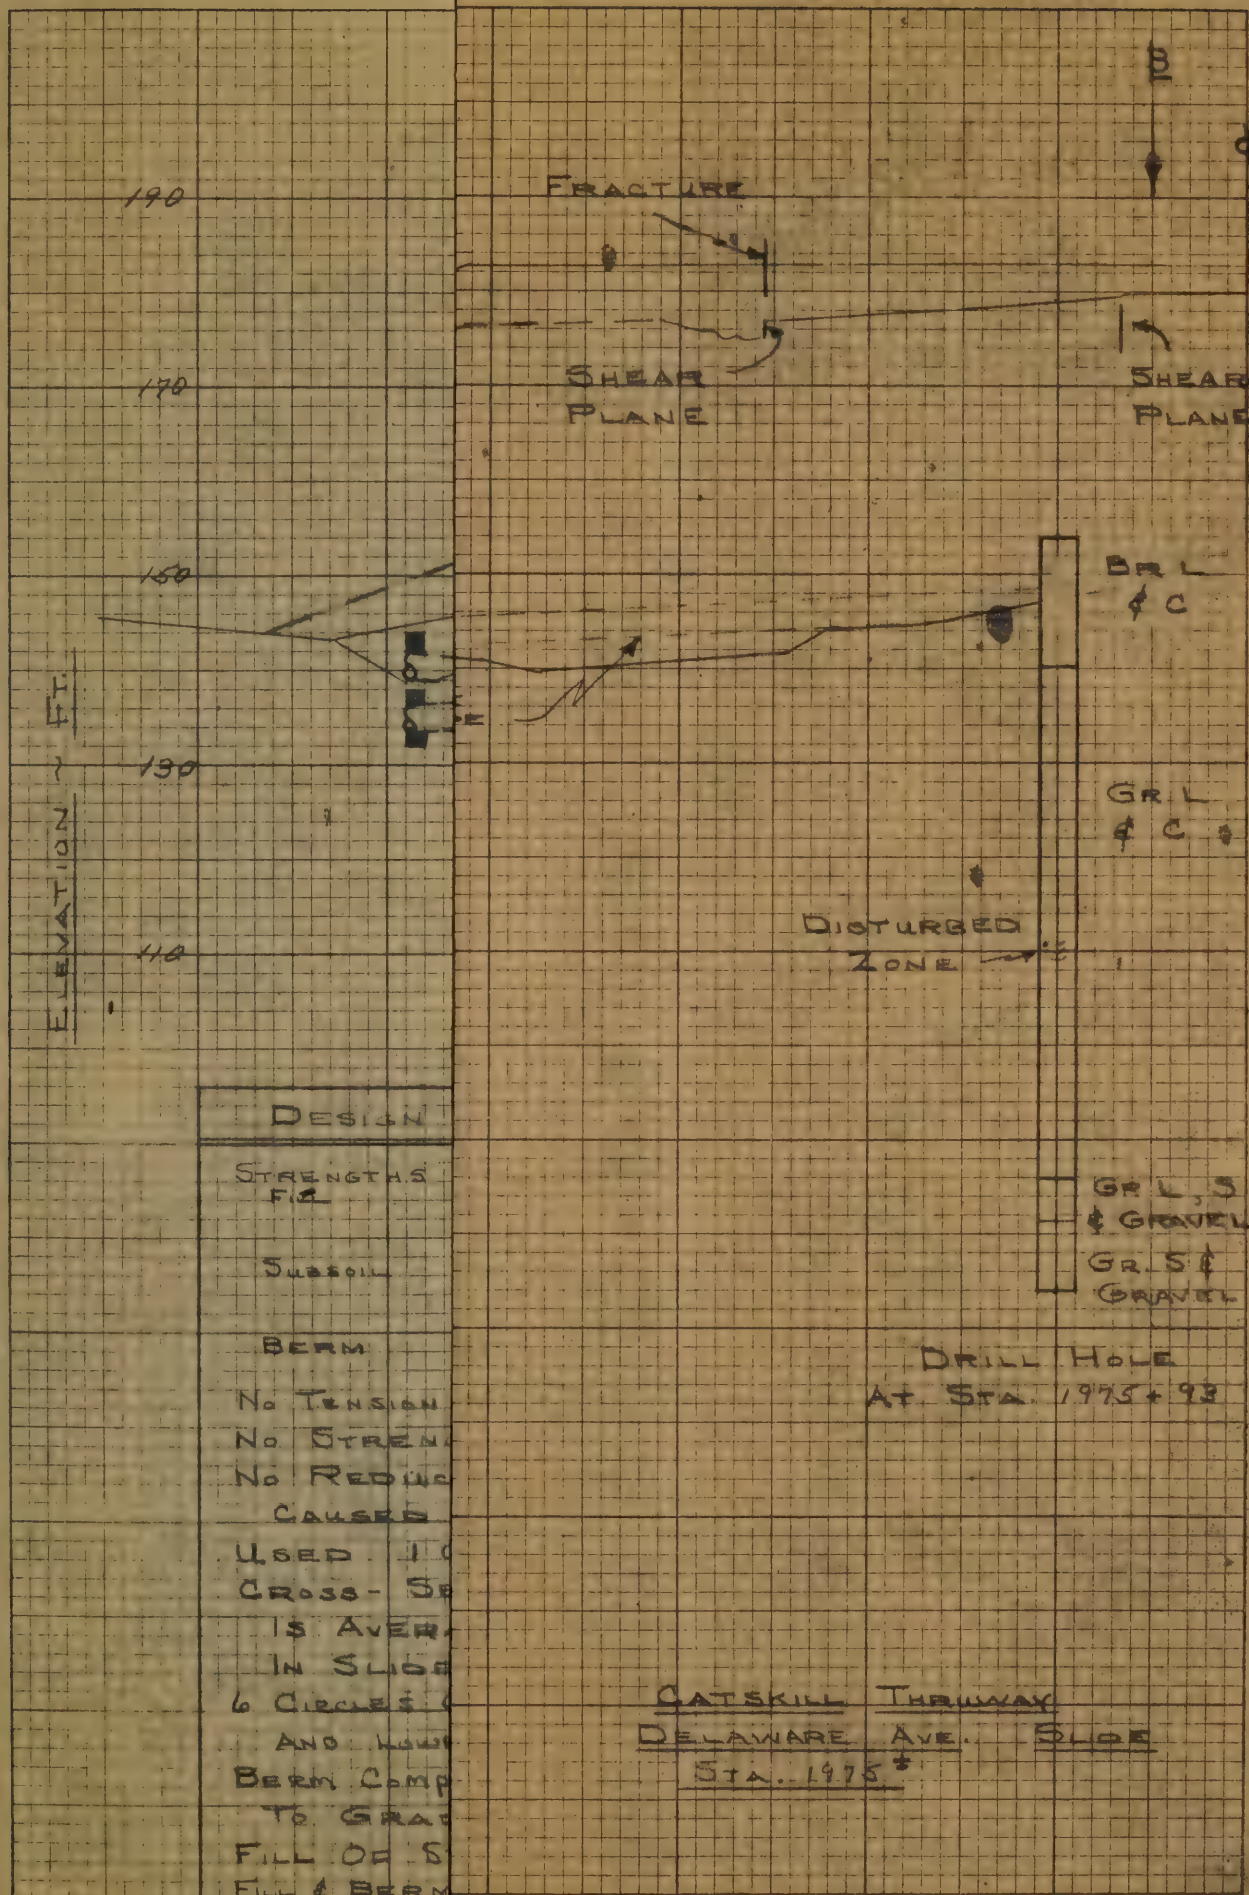
CATSKILL THRUWAY  
DELAWARE AVE. SLIDE  
STA. 1975+

All cross-sections taken subsequent to the slide disclosed the berms lacked an average of 2 ft in height and 5 ft. in width. The slide, with its center over the berm, disallows the possibility of the slide motion causing an apparent decrease in berm size.

A widening of the fill to allow for the addition of an acceleration lane caused a worse condition than anticipated. The effective height of fill under the shoulder is increased by moving the shoulder outward over a ground surface that is sloping downward from the center line.

The original analysis assumed a constant unit weight, but the plans allowed for unsuitable material weighing approximately 110 PCF to be used in the berm. Therefore, in every 8 ft. of berm height, 1 ft. of effective weight is lost.

1) extend the berm an additional 90 feet, for a total of 140 feet, continuing the original surface on a slope of 1 on 50 to the shoulder edge. The end slope should be 1 on 2 1/2 to permit use of unsuitable materials from clay cuts. The berm should merge with the surrounding ground with a smooth transition. The length of berm has been made to cover the toe of the mud wave developed within the slide area.

2) an inspection of the 36 inch reinforced concrete pipe has shown that there is a definite shear break and half-diameter displacement approximately under the left embankment shoulder. Also, the 4 joints immediately upstream from the shear displacement showed minor vertical faulting and horizontal displacement in the order of 6 inches between joints. The pipe from the downstream end to the failure is to be excavated and relaid and the pipe extended 110 ft. to a new head-wall to coincide with the end slope of the new berm.

The berm construction should precede or proceed concurrently with the new pipe excavation to provide stability at all times.

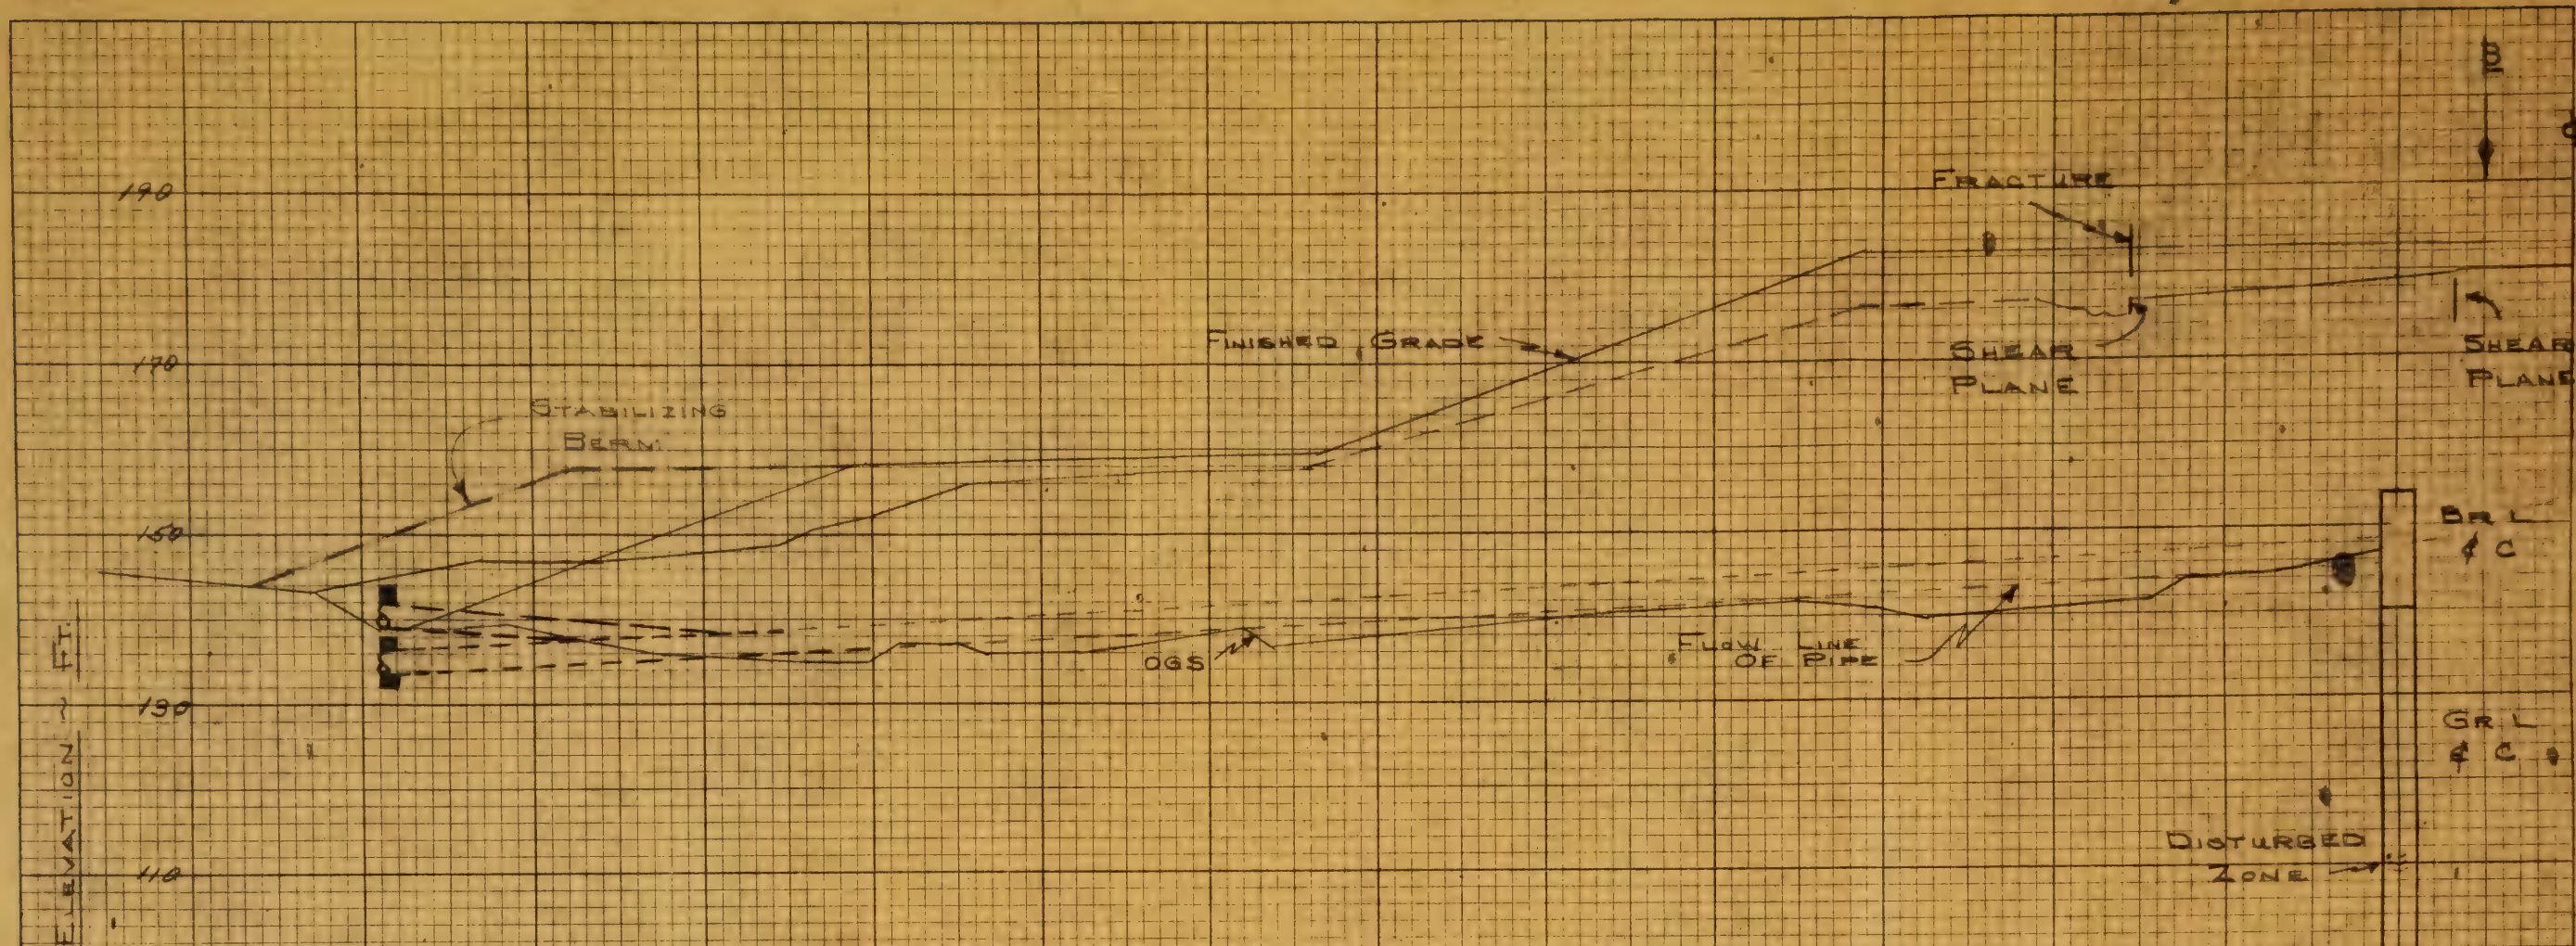
CATSKILL THRUWAY  
DELAWARE AVE. SLIDE  
STA. 1975+

DESIGN CONDITIONS	CONDITIONS AT FAILURE
<p>STRENGTHS Fill <math>C = 1000 \text{ #/ft}^2</math> <math>\phi = 0</math> <math>\gamma = 130 \text{ #/ft}^3</math></p> <p>Subsoil <math>C = 400 \text{ #/ft}^2</math> <math>\phi = 10</math> <math>\gamma = 85 \text{ #/ft}^3</math> SUBMERGED</p> <p>BERM <math>\gamma = 110 \text{ #/ft}^3</math></p> <p>NO TENSION CRACKS CONSIDERED. NO STRENGTH IN THE BERM. NO REDUCTION IN STRENGTH CAUSED BY FORMER SLIDE.</p> <p>USED 1 ON 2 SLOPES CROSS-SECTION AT STA 1975+50 IS AVERAGE OF CONDITIONS IN SLIDE</p> <p>6 CIRCLES GAVE CRITICAL CIRCLE AND LOWEST SAFETY FACTOR</p> <p>BERM COMPLETED BEFORE FILL WAS TO GRADE</p> <p>FILL OF STANDARD DIMENSIONS USED</p> <p>FILL &amp; BERM A CONSTANT <math>130 \text{ #/ft}^3</math></p>	<p>STRENGTHS Fill <math>C = 2700 \text{ #/ft}^2</math> <math>\phi = 25</math> <math>\gamma = 127 \text{ #/ft}^3</math></p> <p>EVIDENCE OF <math>C = 300 \text{ TO } 600 \text{ #/ft}^2</math> <math>\phi = 5 \text{ TO } 10</math></p> <p>SLOPES WERE 1 ON 2 1/4</p> <p>BERM NOT BROUGHT TO GRADE OR WIDTH</p> <p><math>110 \text{ #/ft}^3</math> UNDER SHOULDER AND BERM</p>

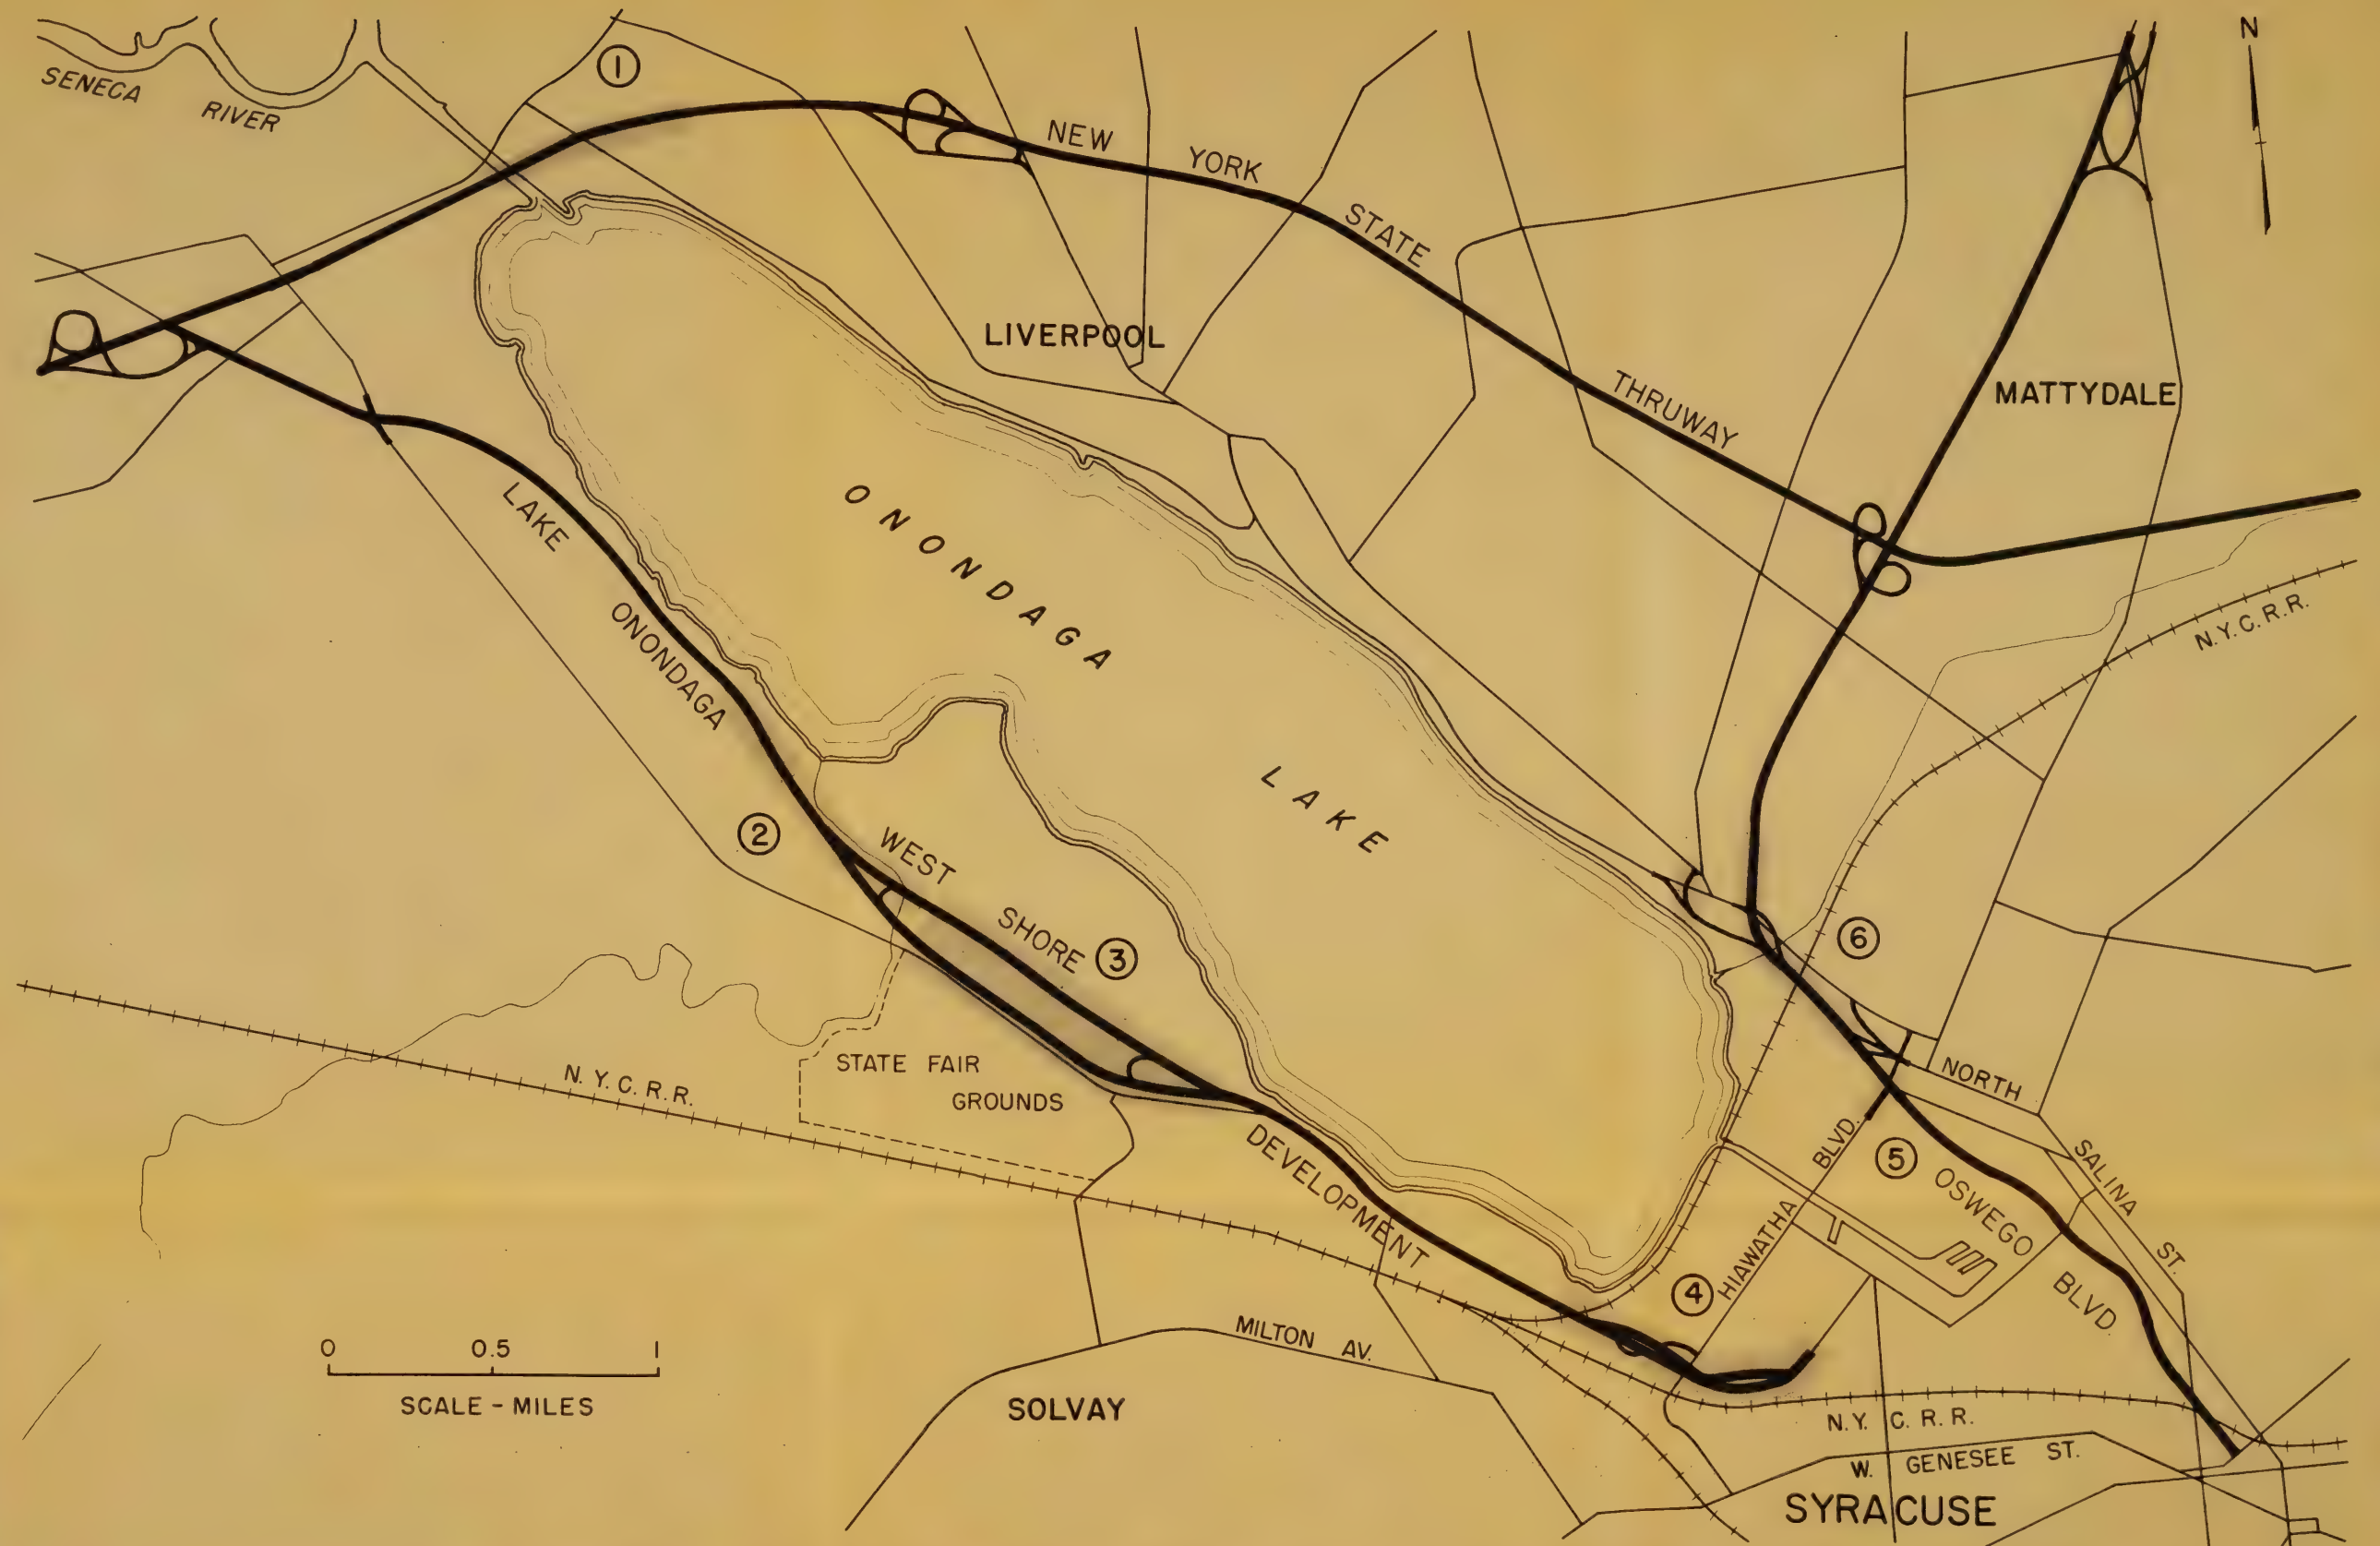
# LOCATION PLAN - SYRACUSE AREA

Figure No. 1 shows a plan location of these main highways which either have been built, are under construction, or are in various stages of design. Going across the top of the slide is the New York State Thruway. This, of course, has been completed. The foundation problems encountered for this project are in the vicinity of the lake outlet and are shown shaded near the No. 1.

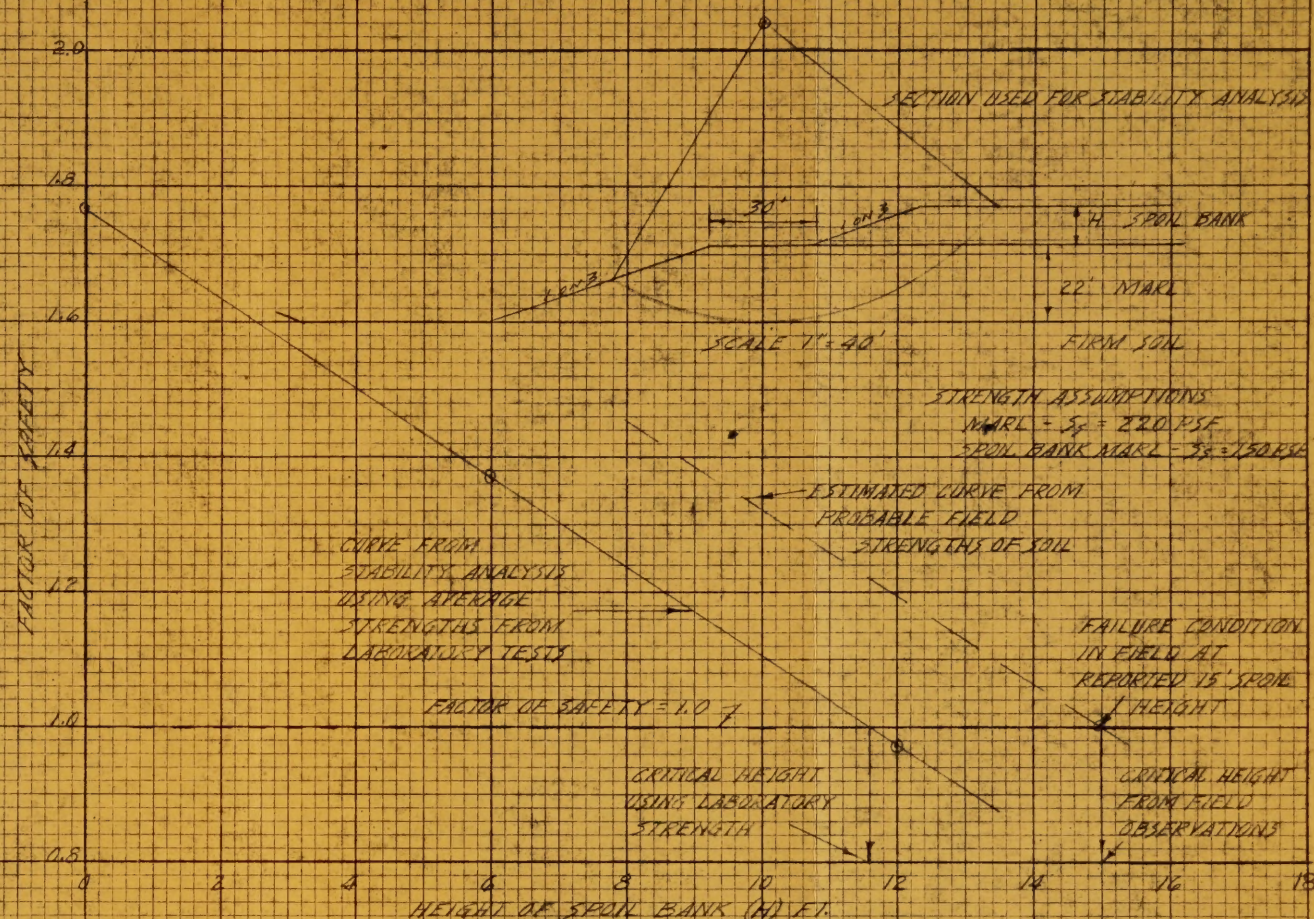
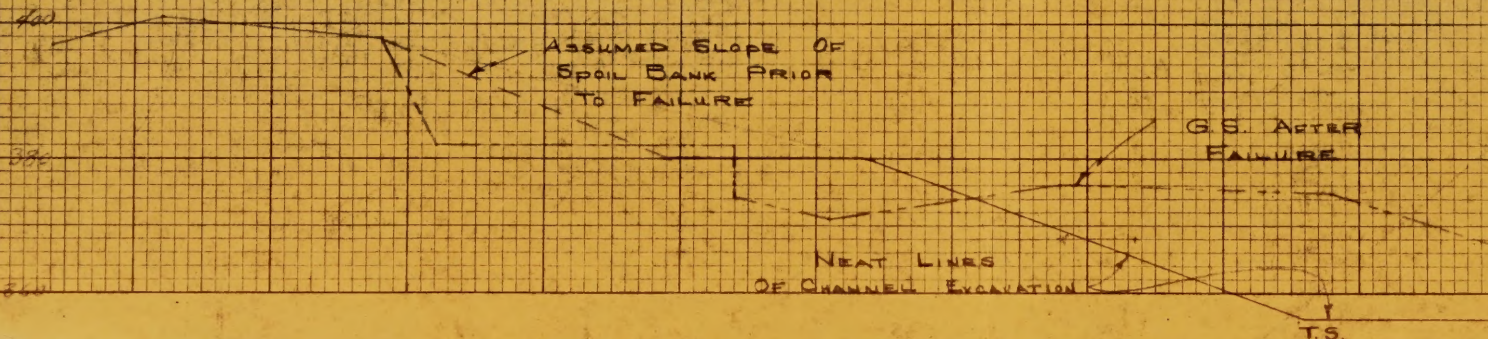
STABILITY ANALYSIS  
SPOIL BANK SLIDE  
CLYDE RIVER RELOCATION  
TYRE-MONTEZUMA CT 51-6

At the time of the slide, there were slides in both the spoil bank and in the marl foundation. Strength values of  $\phi = 12.5^\circ$   $c = 300 \text{ #/ft}^2$  for the marl were obtained from the lab. tests for the Thruway crossing Montezuma Swamp. Strength values of the spoil bank were obtained from Taylor's curves by the above computations to be  $c = 150 \text{ #/ft}^2$ ,  $\phi = 0^\circ$ .

CRITICAL HEIGHT FROM FIELD OBSERVATIONS

In that area where the slide occurred, because of the remolding of the subsurface soils, it was recommended that the height of spoil area in back of the 30 ft. berm not exceed 5 ft.
